14  
 Paper presented at the ASTM  
 Symposium on Applications  
 Related Phenomena in Titanium  
 Alloys, held in Los Angeles,  
 California, on April 18-19, 1967;  
 to be published in an ASTM Special  
 Technical Publication.

THE INITIATION OF HOT-SALT STRESS CORROSION  
CRACKING OF TITANIUM ALLOYS

By S. P. Rideout, Savannah River Laboratory,  
E. I. du Pont de Nemours and Co., Aiken, S.C.

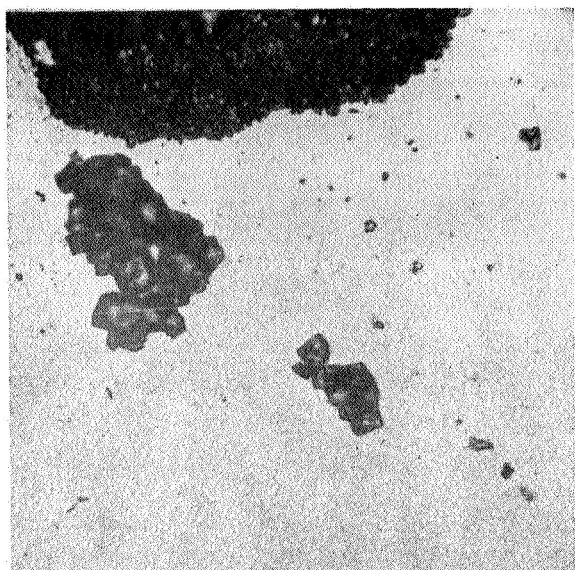
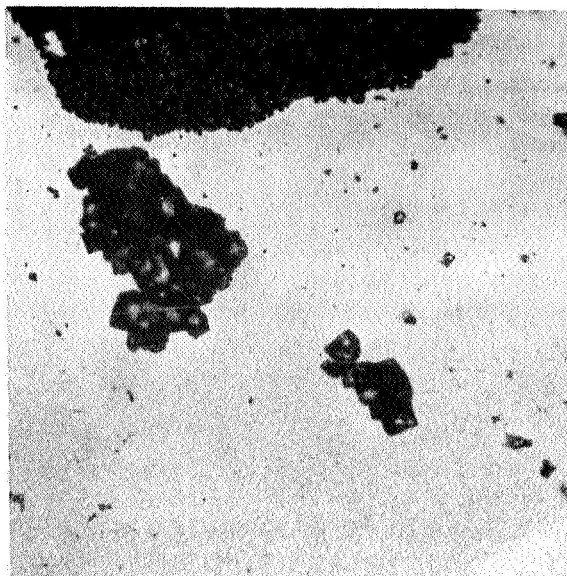
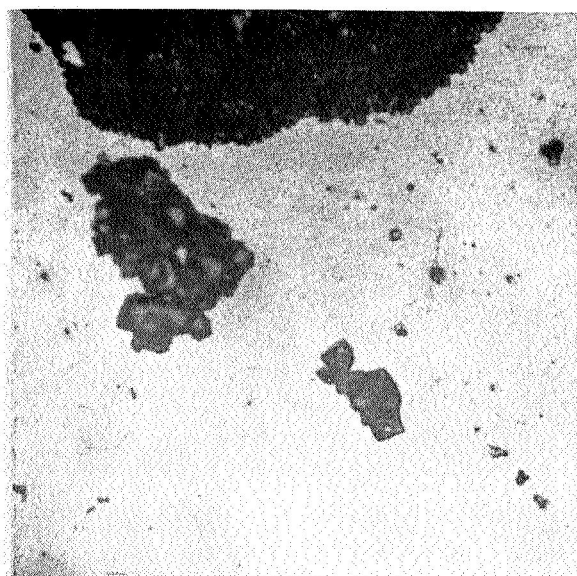
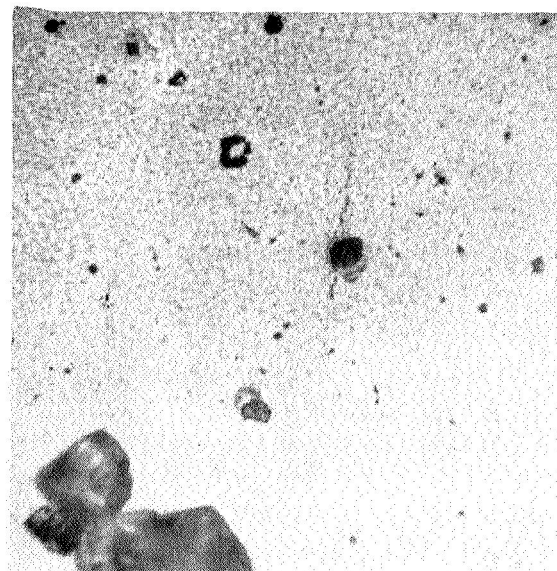
a. Salt deposit at room temperature (320X)

b. Same as (a) after reaching 650°F (320X)

c. Same as (b) after 80 mm (320X)

d. Same as (c) enlarged to 800X

Figure 1. Hot-Stage Microscopy of NaCl Cracking of Ti-8Al-1Mo-1V at 650°F

Initially, the corrosion stains appeared as microscopic speckles that developed on the metal around the salt crystals. The number of speckles increased with time, Figure 1a,b,c, and gradually formed a fairly continuous stain around the salt. However, the stains did not appear to form by surface diffusion of reaction products spreading out from salt-metal contact areas, and the initiation of cracking occurred before the stain became continuous, Figure 1d.

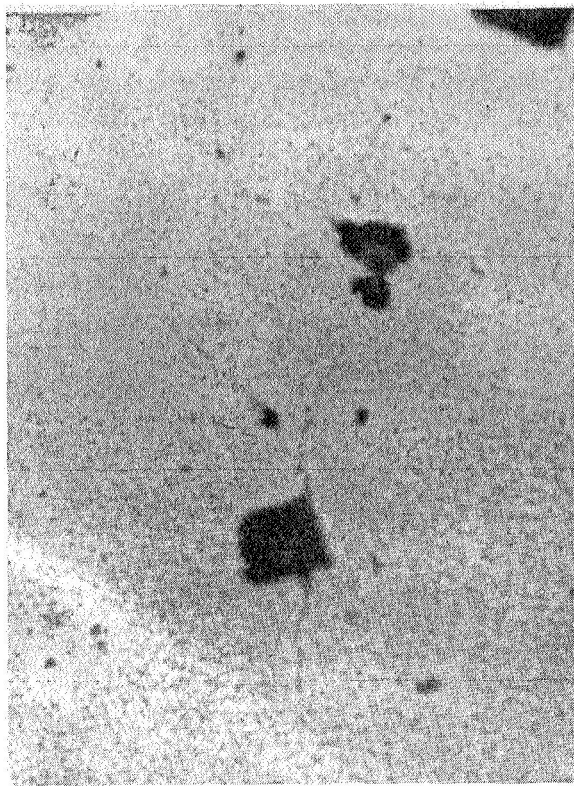
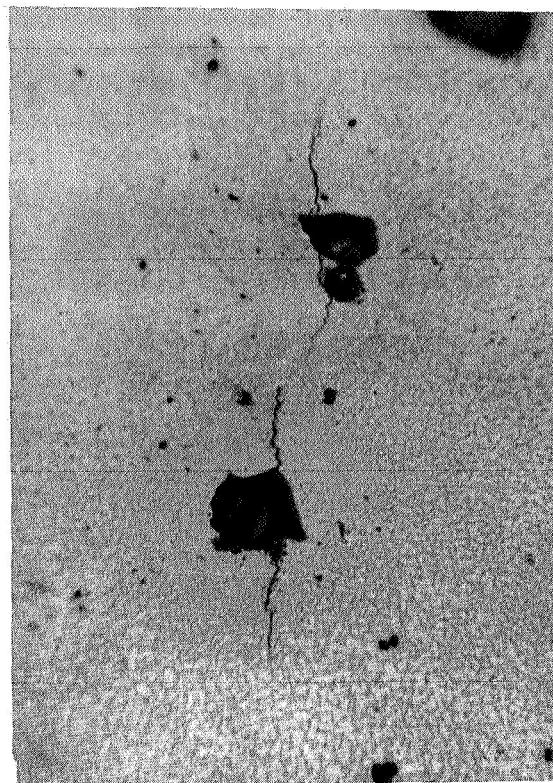
a. 85 Minutes after reaching  
650°F

b. 185 Minutes after reaching  
650°F

Figure 2. Hot-Stage Microscopy of NaCl Cracking of Ti-8Al-1Mo-1V at 650°F (720X)

Cracks appeared abruptly, propagated rapidly for a short distance, and then apparently paused for additional corrosion-embrittlement to occur. Further propagation also appeared to occur by abrupt extensions. Although cracks always originated at points of salt contact, there was no apparent relationship between the size of the salt crystals and the size of the cracks. Many cracks were initiated at extremely small salt crystals. At various intervals after the first cracks appeared, additional cracks were initiated at other sites. In many cases, these sites were close together and the cracks connected to form larger cracks. An example of this is shown in Figure 2.

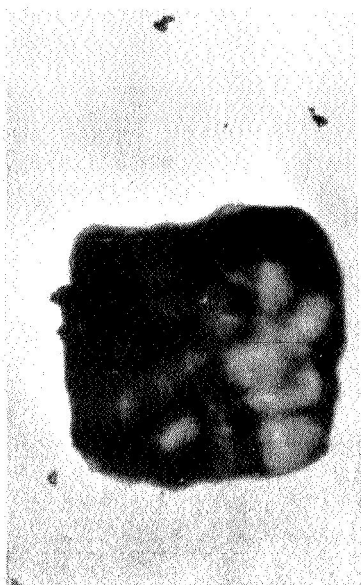
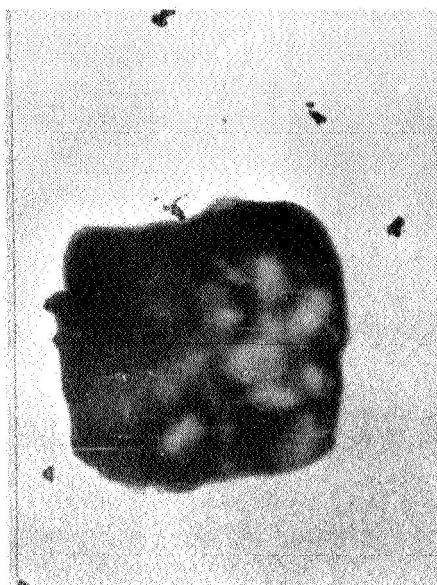
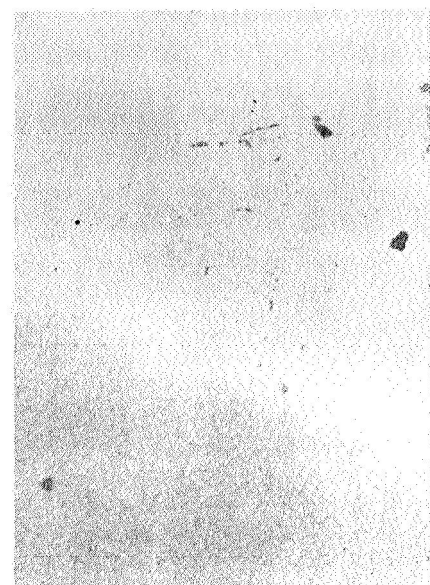
a. Room temperature

b. Same as (a) after  
90 minutes at 650°F

c. Same as (b) after  
cooling to room  
temperature and  
removal of salt  
crystal

Figure 3. Hot-Stage Microscopy of Ti-8Al-1Mo-1V Exposed to  
Pre-dried NaCl at 650°F (300X)

that had not been wetted with salt water were heated with and without predried salt crystals on their surfaces. No corrosion stains were produced in either case, which indicated that adsorbed constituents caused the stains, and also demonstrated that moisture is a vital ingredient in the hot-salt corrosion process, Figure 3. Previous work<sup>(5)</sup> with radiotracer  $H^3$  (tritium) in the solutions from which salt was deposited on specimens showed that hydrogen is absorbed in salt-corroded areas. The combined results of the radiotracer studies and hot-stage microscopic observations support the hypothesis that absorption of corrosion-produced hydrogen promotes crack initiation.

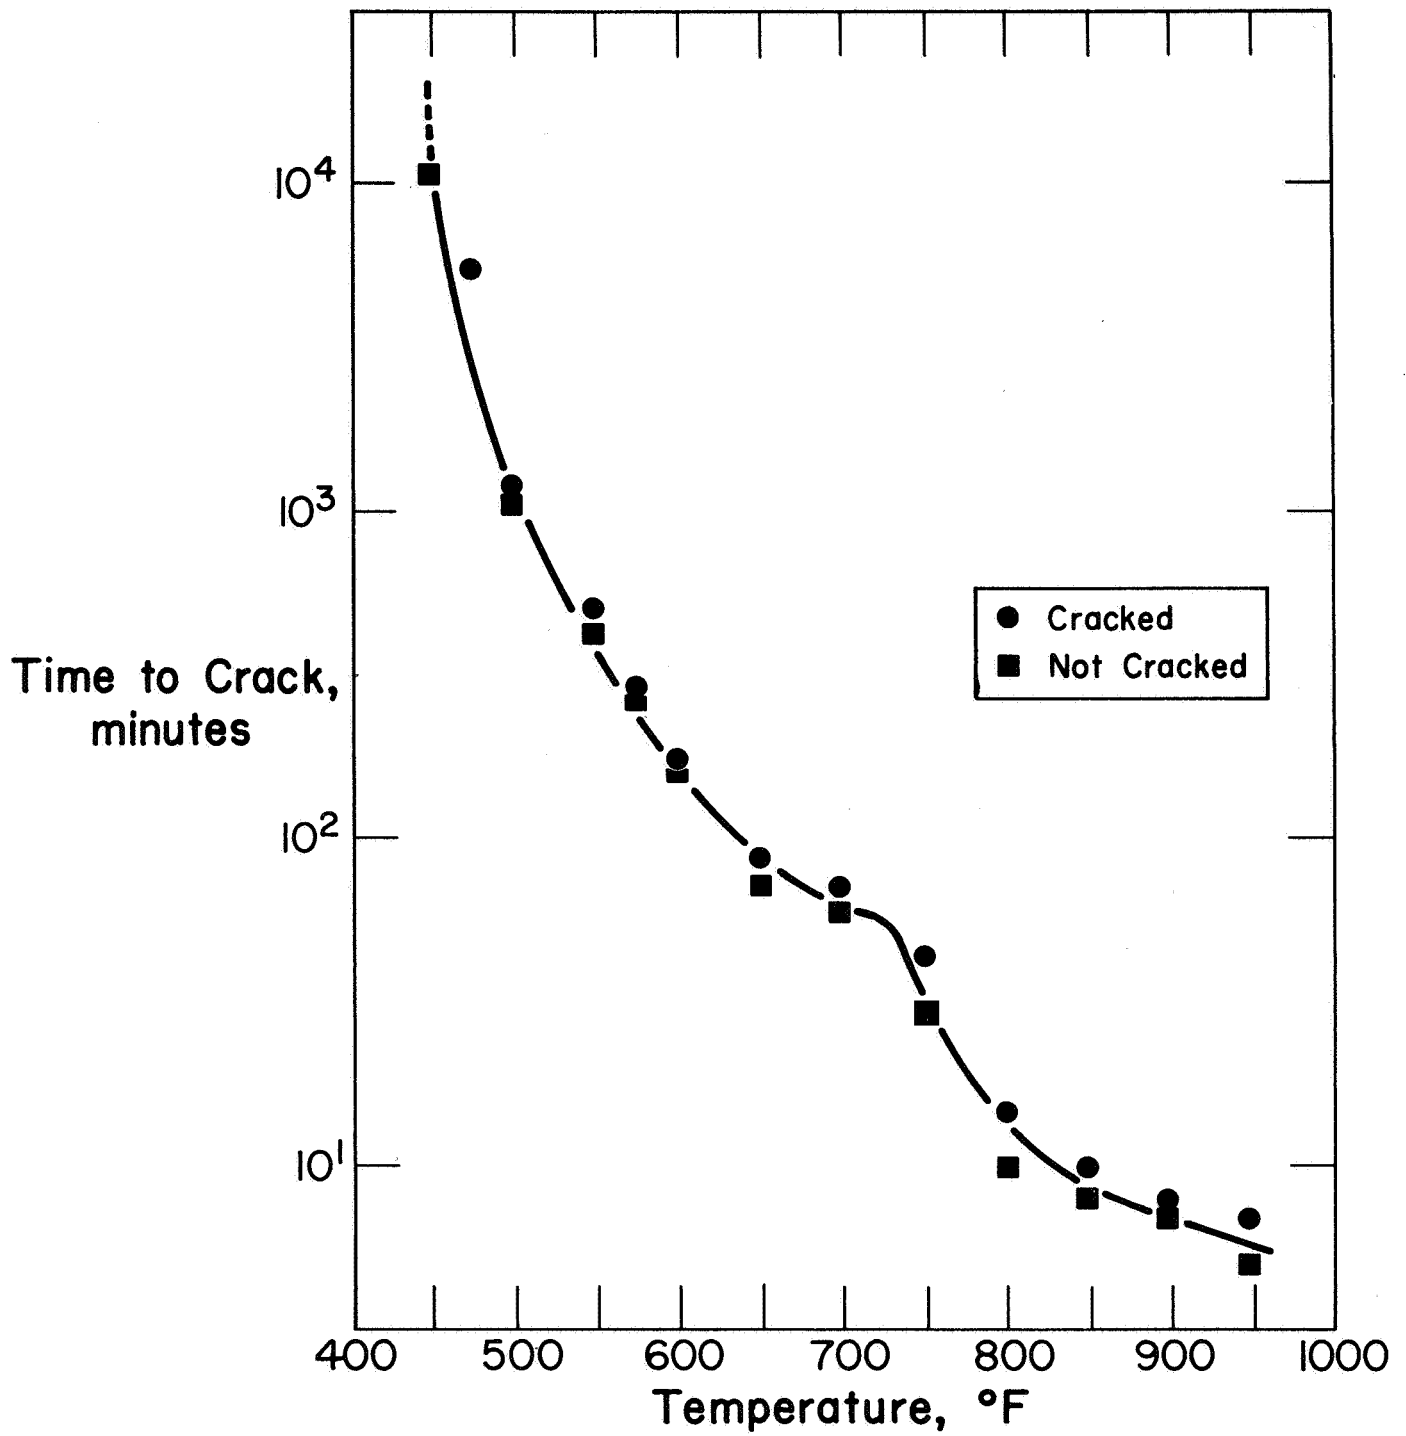
FIG. 4 TIME TO INITIATE CRACKING BY NaCl IN Ti-8Al-1Mo-1V vs TEMPERATURE

The effect of exposure temperature on the incubation period for crack initiation in Ti-8Al-1Mo-1V is shown in Figure 4. The incubation period decreased from about 96 hours at 475°F to 20 hours at 500°F to about 1 hour at 700°F. An obvious inflection occurred in the incubation-temperature curve between 700° and 750°F. From 750° to 950°F the incubation period decreased from about 45 minutes to only about 6 minutes. These results indicate two significant points for discussion: (1) the long incubation periods at the lower temperatures provide an explanation for previous reports that cyclic heating to 550°F caused less stress corrosion damage than continuous heating at the same temperature,<sup>(3,4)</sup> and (2) the inflection in the incubation time-temperature curve indicates a change in the salt stress corrosion process between 700° and 750°F.

The inflection in the incubation time-temperature curve between 700° and 750°F suggests the possible formation of either a liquid or gaseous phase(s) during hot-salt corrosion. Hot-stage microscopy at temperatures above 750°F showed corrosion stains developing very rapidly over the specimen surface for a short distance around salt crystals, but no liquid was actually observed. The stains darkened very rapidly and appeared as a solid corrosion product. It has not been established that the mechanism of cracking requires a liquid phase, or that the mechanism changes at higher temperature. There was no evidence of a liquid phase at temperatures below 700°F, and at temperatures above 750°F crack initiation was detected before the corrosion stains were fully developed. An example of this is illustrated in Figure 5, which shows several frames of a movie taken at one frame per second during heating of a specimen to

It was reported previously that different halide salts cause various degrees of cracking in Ti-8Al-1Mo-1V at 650°F.<sup>(5)</sup> Therefore, the incubation time-temperature curve in Figure 4 is valid only for sodium chloride deposited on metallographically polished specimens of this alloy. A detailed study is now in progress to determine the effects of various salts on the cracking process, and complete results will be reported later. A few preliminary data, presented below, demonstrate that the type of salt has a strong influence.

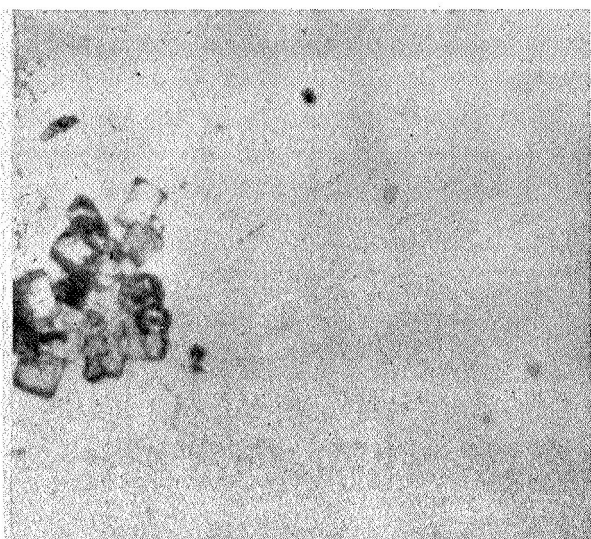
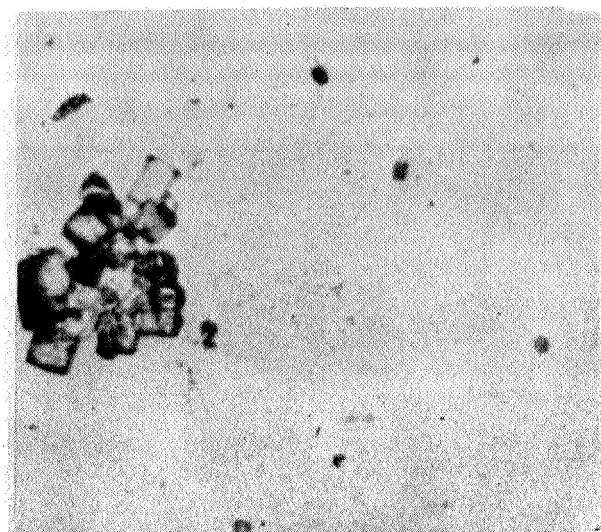
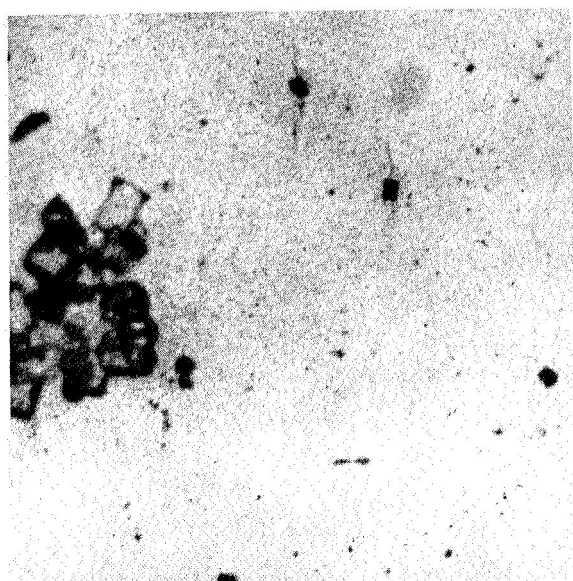
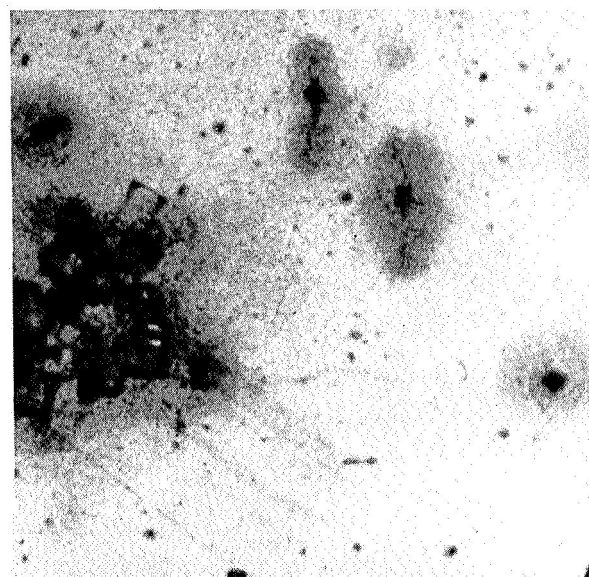
a. Salt deposit at room temperature

b. Same as (a) after 14.5 minutes at temperature

c. Same as (a) after 15 minutes

d. Same as (a) after 17 minutes

Figure 5. Hot-Stage Microscopy of NaCl Cracking of Ti-8Al-1Mo-1V at 800°F (650X)

800°F. Cracks were faintly visible after 14-1/2 minutes (Fig. 5b) and became clearly visible after 15 minutes (Figure 5c). Dark stains then developed around the cracks after 17 minutes (Figure 5d). The inflection in the incubation time-temperature curve may be due to melting at the salt-metal interface on a scale that cannot be resolved by hot-stage microscopy. Further work is needed to clarify this point.

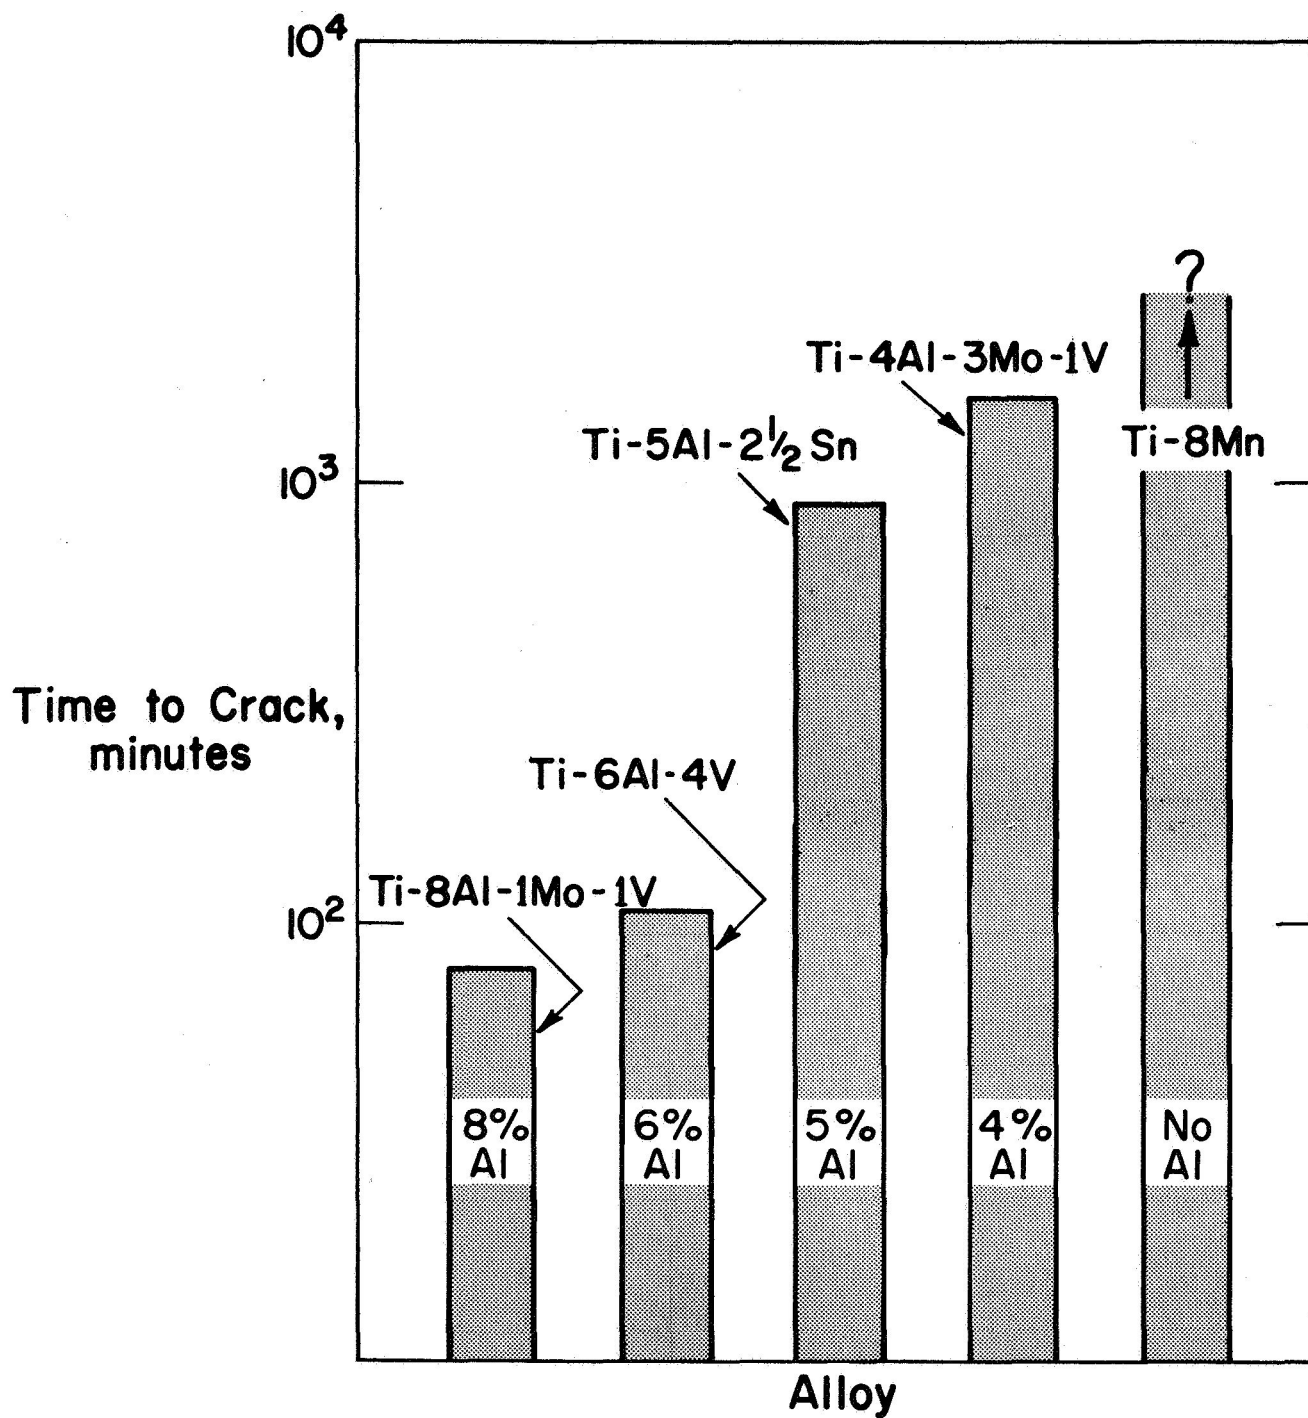
FIG. 6 EFFECT OF ALLOY COMPOSITION ON TIME TO INITIATE CRACKING BY NaCl AT 650°F

The time to initiate cracking by  $\text{NaCl}$  at  $650^\circ\text{F}$  in four aluminum-bearing alloys increased with decreasing aluminum content, as shown in Figure 6.  $\text{Ti-8Al-1Mo-1V}$  was the most susceptible and cracked in 1-1/4 to 1-1/2 hours, whereas  $\text{Ti-4Al-3Mo-1V}$  cracked after 28 hours. Specimens of  $\text{Ti-8Mn}$  were not cracked after 48 hours exposure. Stressed specimens of  $\text{Ti-8Mn}$  were also exposed at  $650^\circ\text{F}$  with  $\text{SnCl}_2$  deposits, previously shown to be much more aggressive than  $\text{NaCl}$ . Although no cracks were visible after 91 hours, specimens cracked during bending at room temperature after the salt was washed off, showing that corrosion embrittlement had occurred, Figure 7.

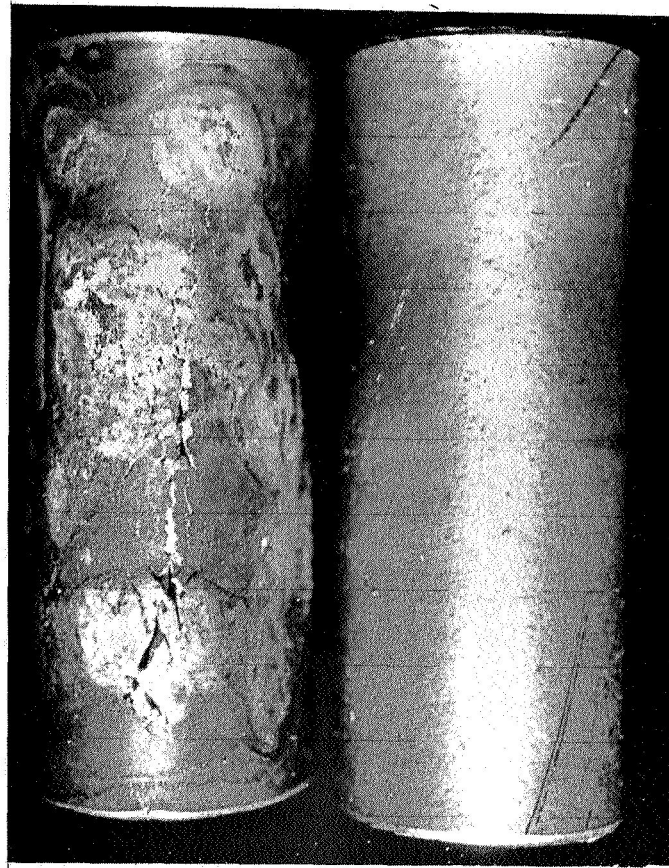
Salt Exposed

Unexposed

FIGURE 7. Corrosion-Embrittlement of  
Ti-8Mn Alloy (5X)

Cracks were not visible after exposure of stressed specimen with  $\text{SnCl}_2$  deposit at  $650^\circ\text{F}$  for 91 hours. Cracks were produced by bending the specimen at room temperature after the salt was washed off.
